## APPENDIX C.2: FIELD FORMS STREAM SITES

# Restoration Site CATO-2018-STRE-0001

## Catoctin Creek Watershed Assessment

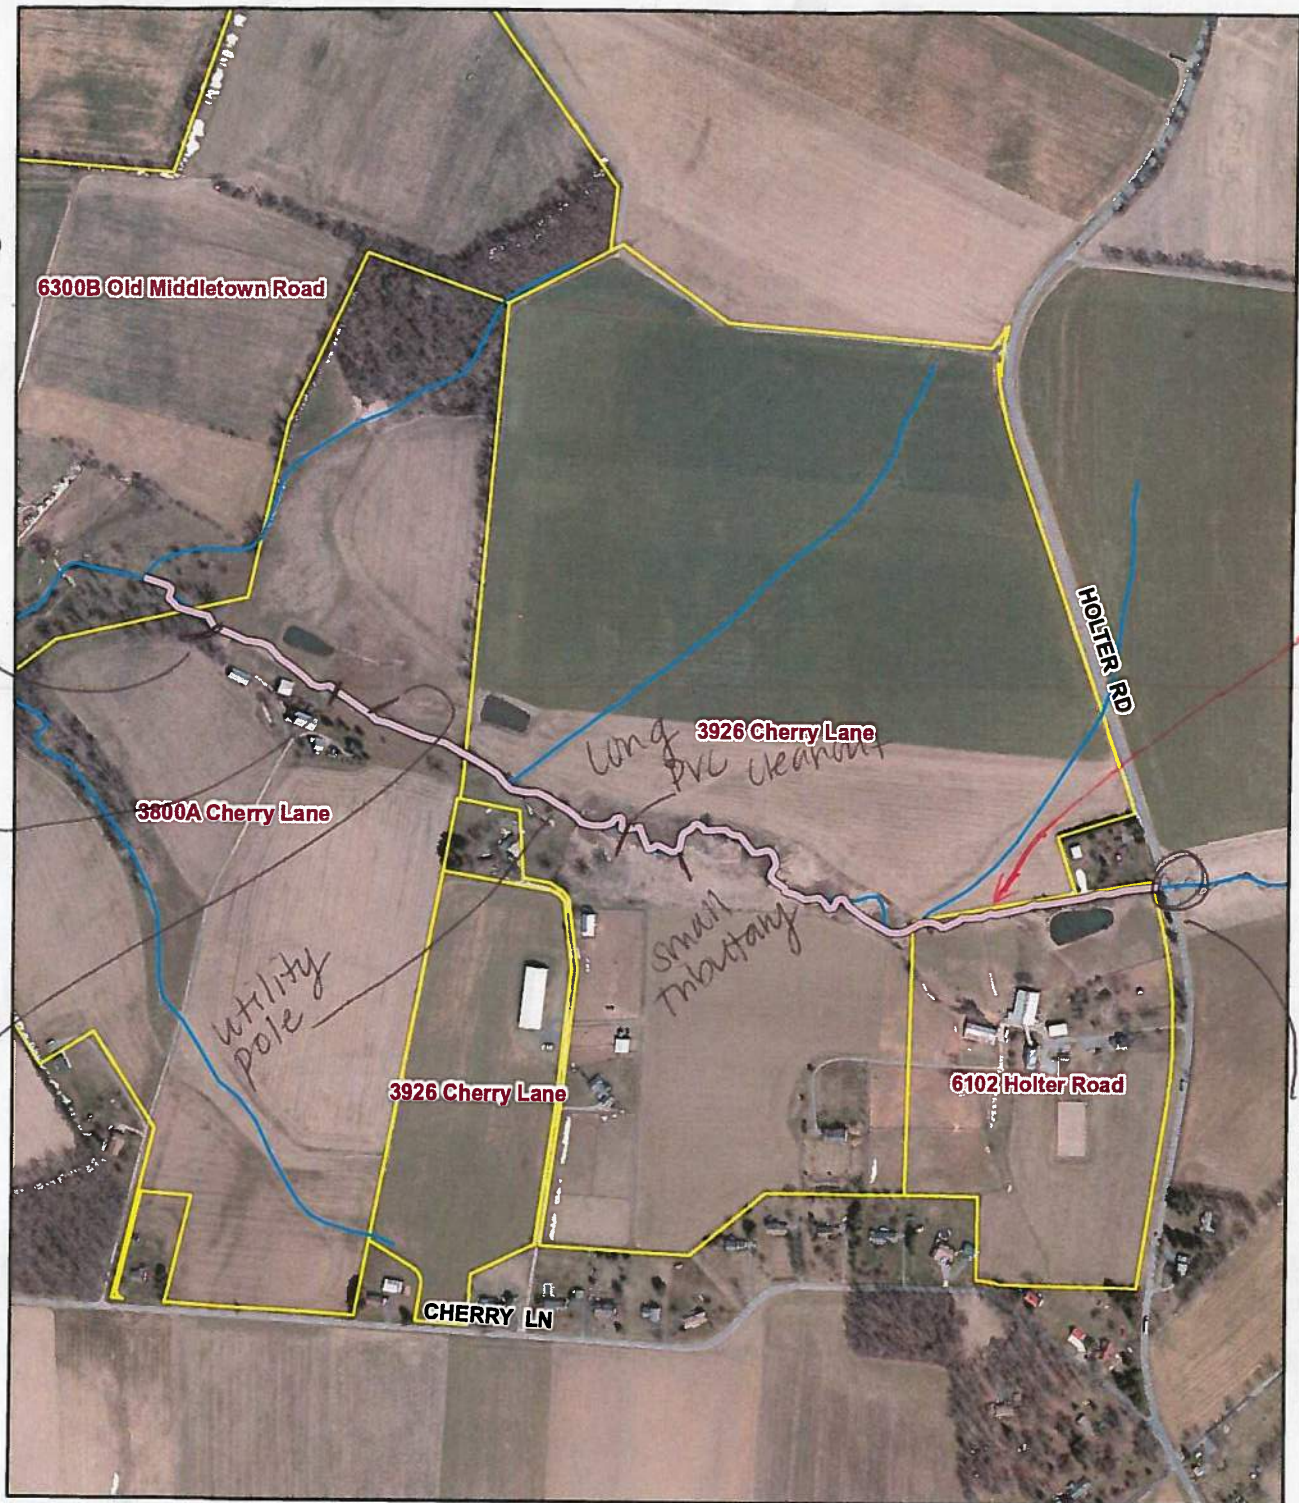
- Restoration Notes (project type, constraints, access, environmental impacts, etc.):  
 Proposed project extends from confluence just DS of Ed Smith Property up to ~~small ditch near Daisy property~~. If permission is obtained from Daisy, could extend project to Holter Rd. Access from Smith driveway would be easiest. Floodplain reconnection feasible for most of the length of the stream, but may be difficult adjacent to Smith Pond. Some tree impacts along western side of Thayer property.

- Tree Planting in floodplain along entire stretch of stream. Cattle already largely fenced out on Smith property.  
 Don wants to note that the stream may be eroding the embankment for the pond that is just downstream of Holter Rd., but we were unable to verify due to not having permission during the field visit.

- Stream Restoration Potential (Circle one) – None Low Medium **High** Length is ~3,300 LF
  - Is there potential for floodplain reconnection? (Circle one) - **Yes** No

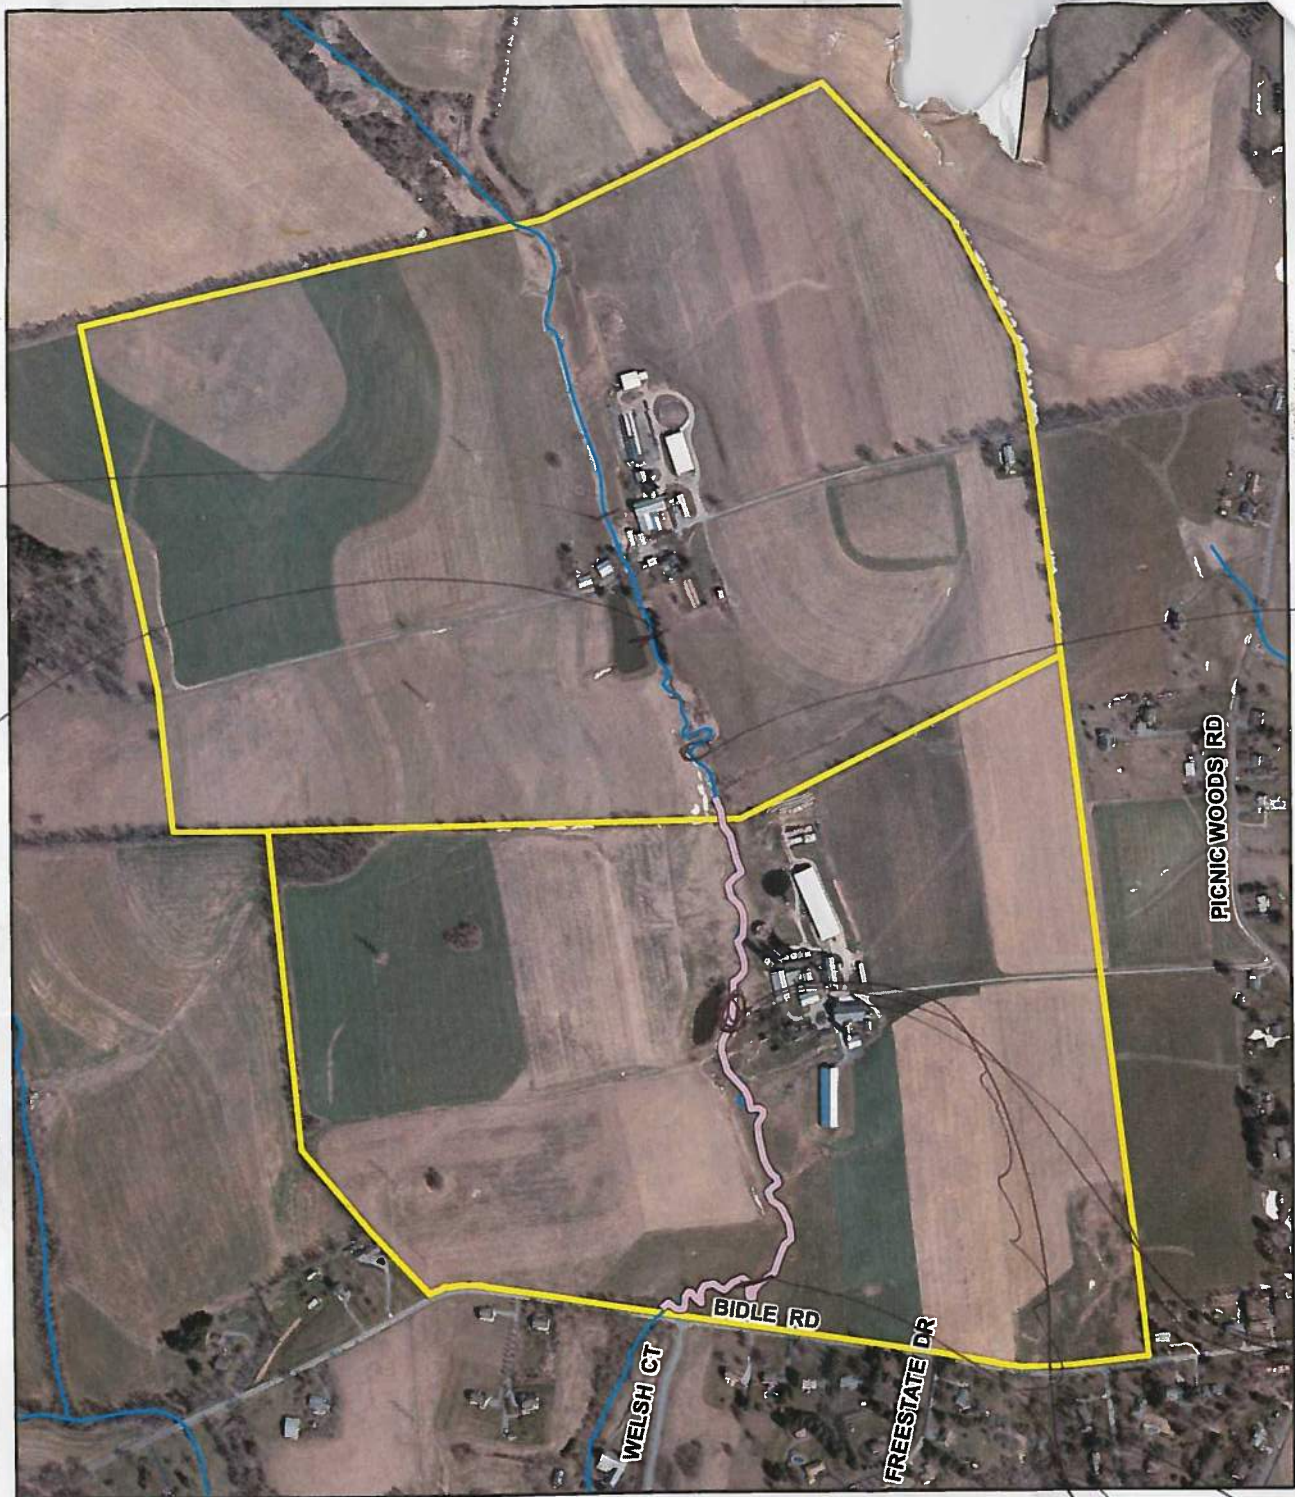
Pipe across stream

Sediment cover by stream bed

seepage

Proposed project extends from Rihode gravel driveway crossing down to Bidle Rd. Access from gravel driveway. Project can consist of reconnection to floodplain, tree planting, and livestock fencing in floodplain. An exposed pipe (iron? clay?) at large meander bend may need to be protected or removed as part of project. A few existing trees would be impacted by project. Poor WQ in reach due to cow access, very turbid + lots of algae.

Potential to add linear practice to slope that discharges to stream, but DA may be too large.

Abundant aquatic life observed upstream of driveway crossing. Could add culvert as part of restoration project to allow for easier passage of aquatic life.

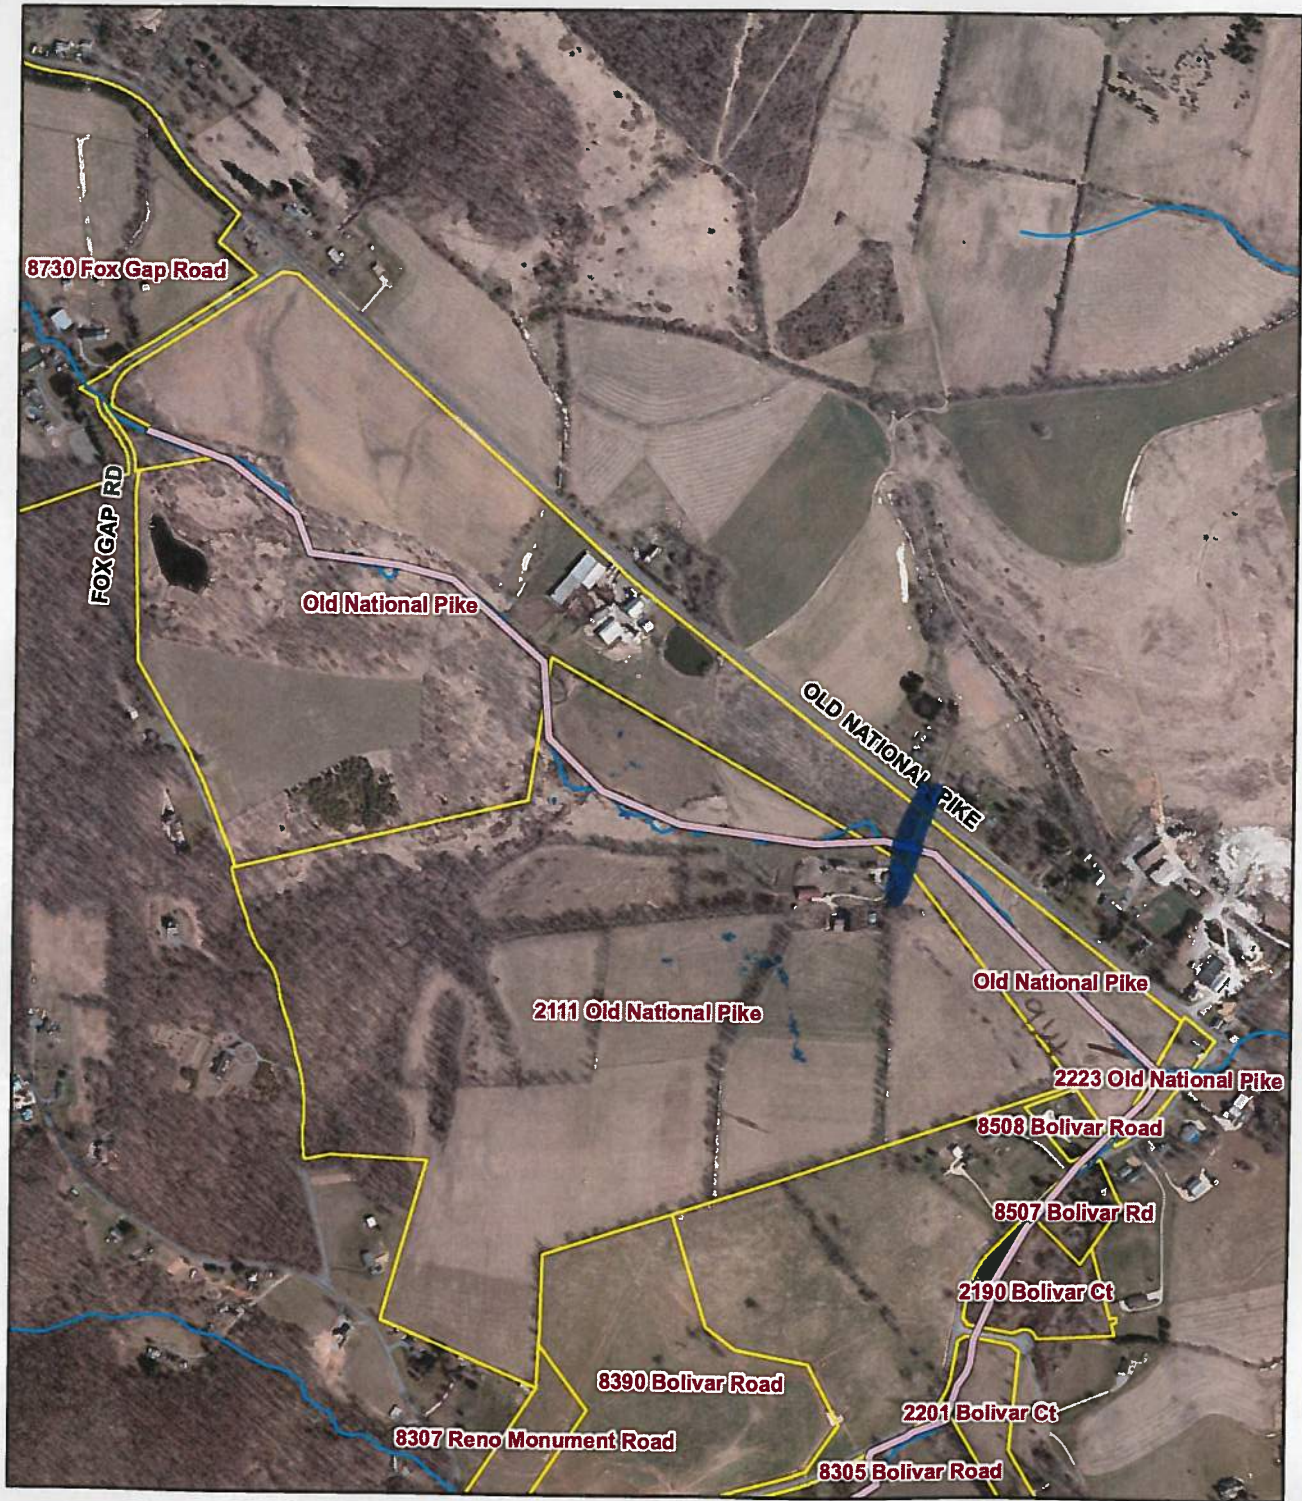
# Restoration Site CATO-2018-STRE-0018

- Stream Restoration Potential (Circle one) – None Low Medium **High** ~ 2,200 LF  
800 along main stem  
1,500 along trib
  - Is there potential for floodplain reconnection? (Circle one) – **Yes** No
  - Restoration Notes (project type, constraints, access, environmental impacts, etc.):  
Proposed project includes main channel between Bolivar Rd. and Old Mahanul Pike, and trib that runs along US-40 on Brunner property. Most of project can be accessed from gate used to enter Brunner property from Bolivar Rd. Project includes connecting channel to floodplain, planting trees, and providing
- Other Restoration Opportunities Present (Circle one) – **None** One Several livestock fencing
  - If opportunities present, list types and locations (and mark on map):

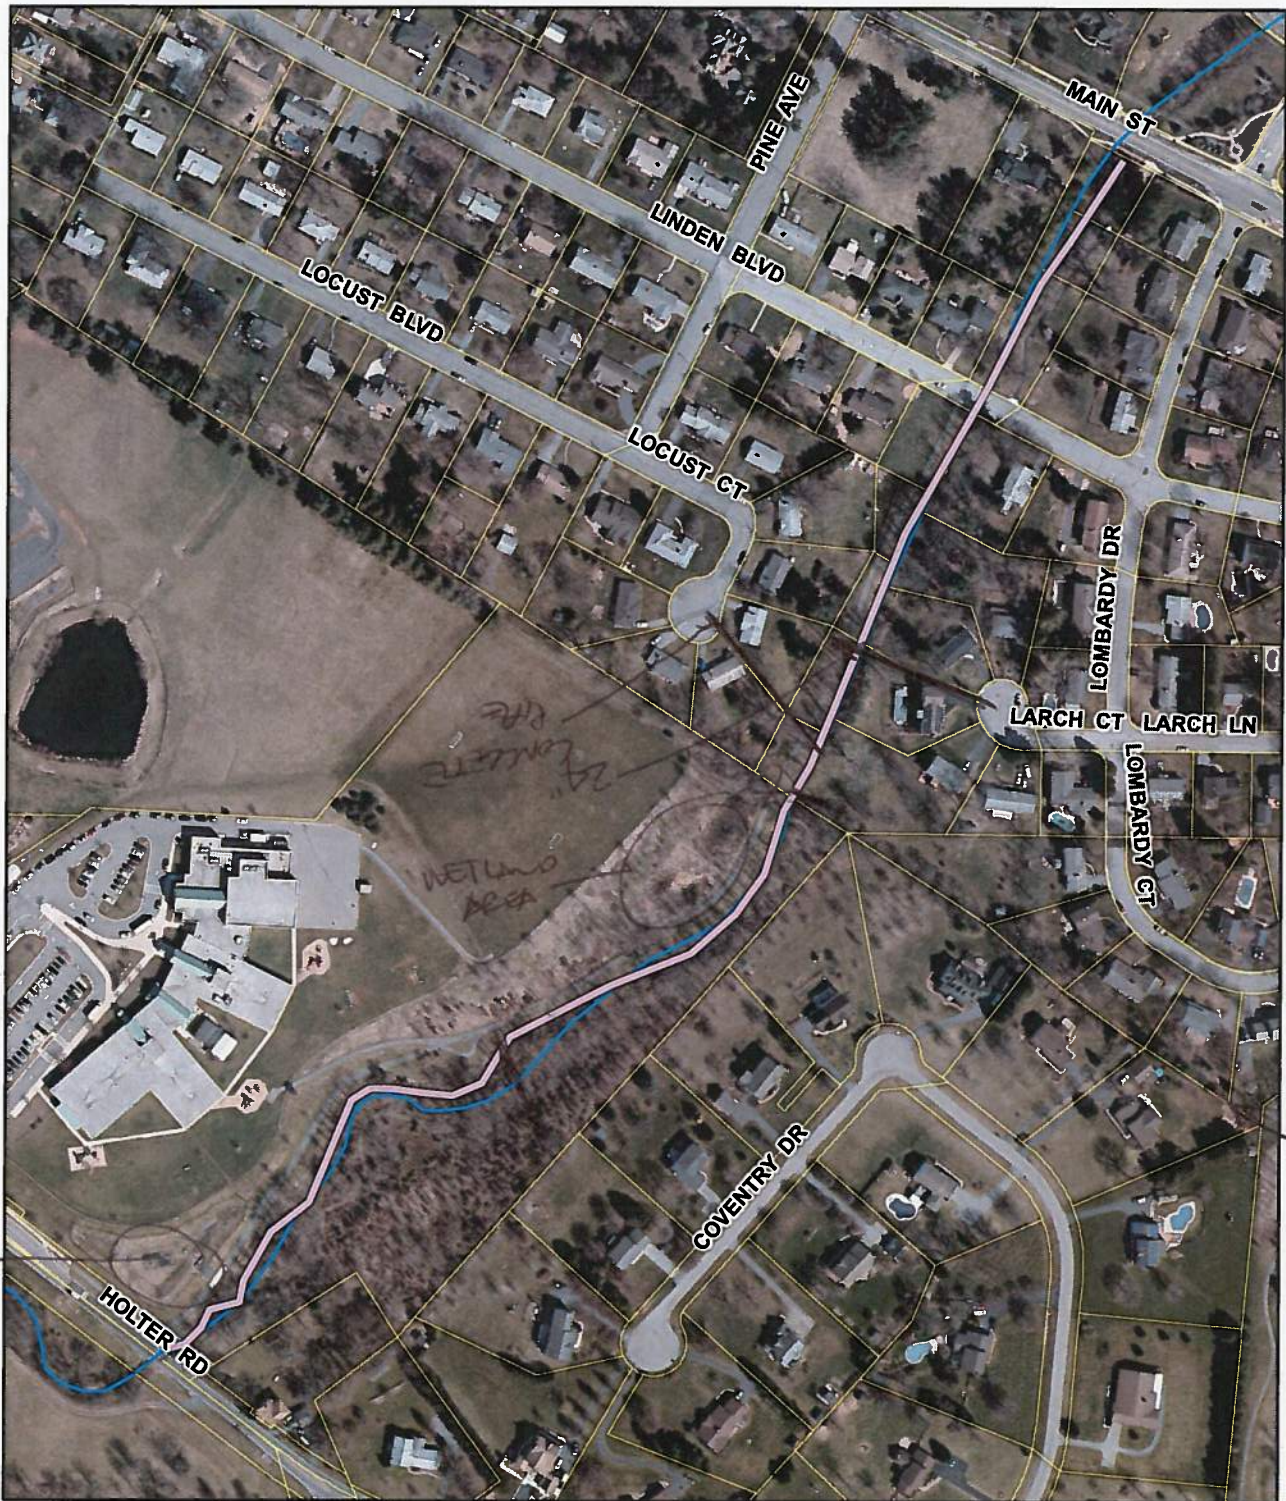
# Restoration Site CATO-2018-STRE-0021

SEWER EASEMENT ADJACENT TO THE WALKING PATH

CONCRETE RETAINMENT AREA

POTENTIAL ANNEXATION TO NORTH OF THE PARK

DRY WEATHER FLOW FROM COMPANY CT?

TRAIL LINE

SAND FILTER?

STAGNANT ON OTHER SIDE

- PROJECT SITE CONSTRAINED DUE TO SEWER LINE, WALKING PATH & PRIVATE PROPERTY

*- PROJECT SITE VERY CONSTRAINED DUE TO STEEP SLOPE, SEWER LINE, & WALKING PATH*

- THERE IS A SD PIPE FROM LARCH CT. WHICH COULD BE DAYLIGHTED UP SLOPE ON WEST SIDE OF PATH & BMP INSTALLED DEPENDING ON D.A. → NEED TO EVAL. DA TO THIS SD.

*- WETLAND RESTORATION ON WEST SIDE OF WALKING PATH*

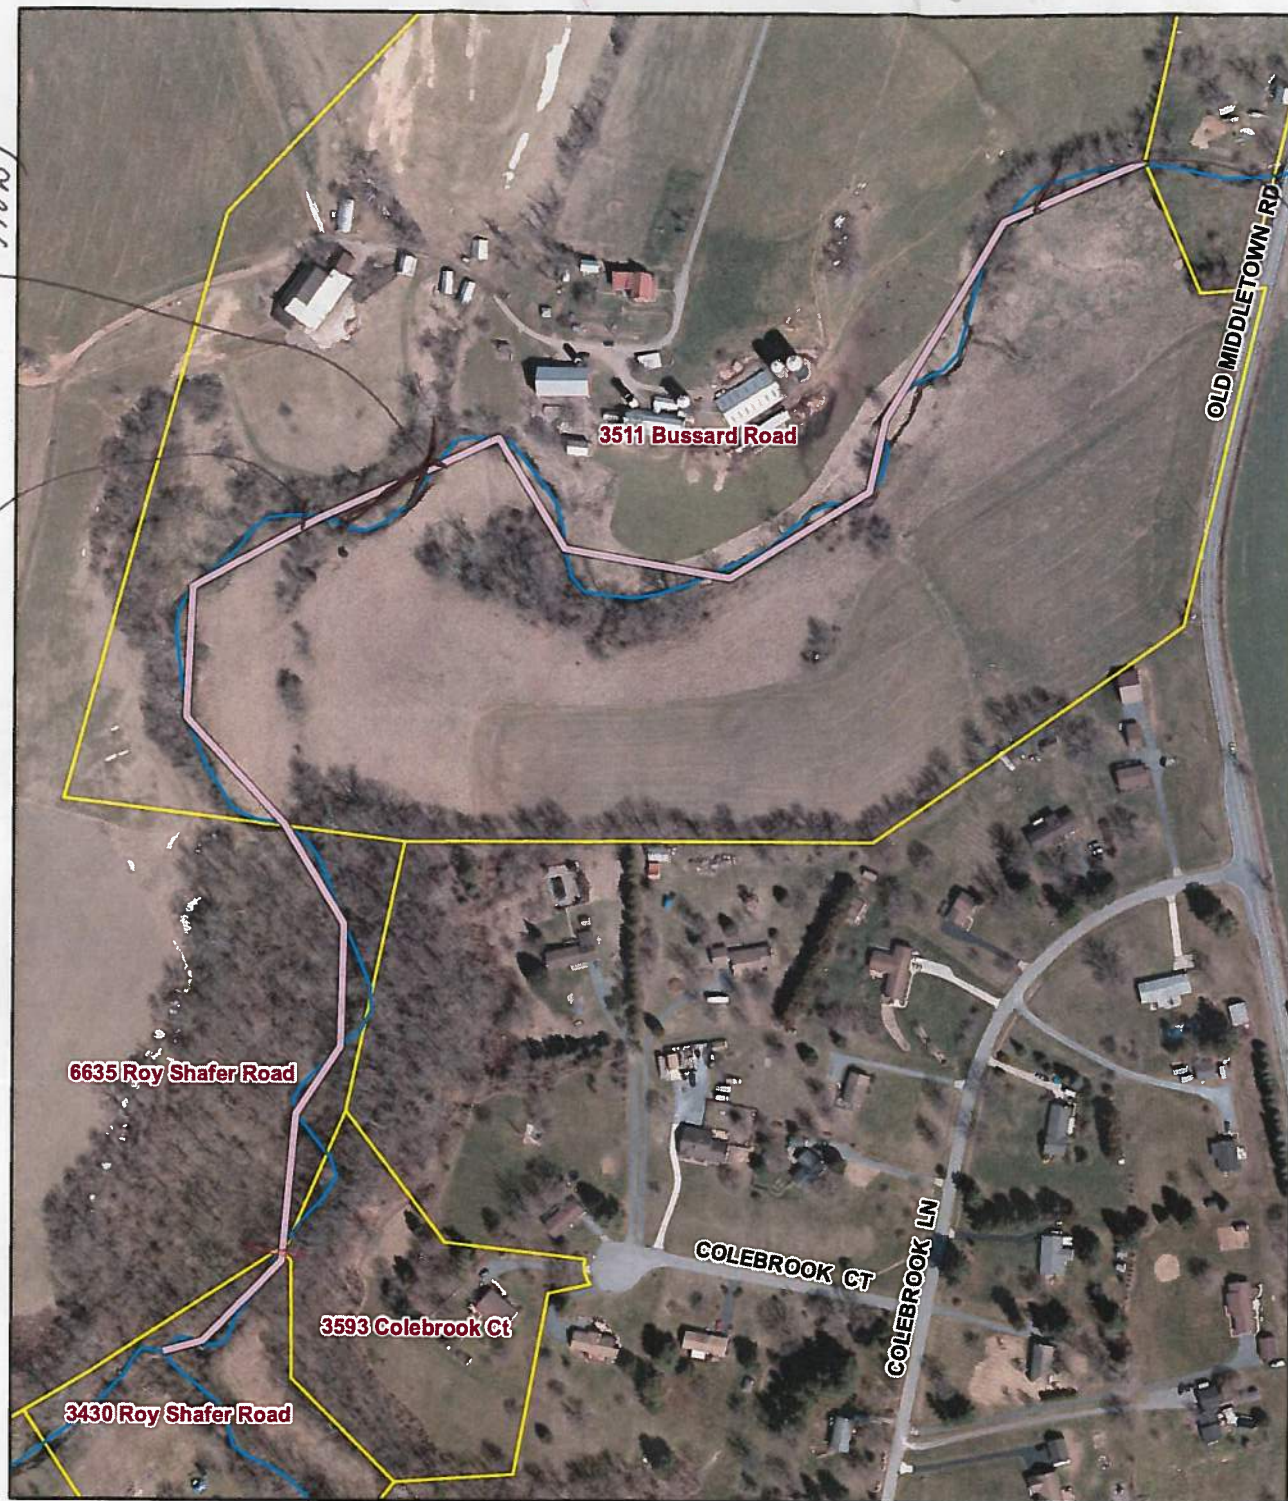
# Restoration Site CATO-2018-STRE-0022

This is the portion of the site where there becomes little to no forested buffer on either side of the stream. Roughly corresponds to northern parcel. Site has a fairly wide floodplain that can be reconnected to the stream in some areas. The issue is access. No easy access due to steep slopes and no existing road to the stream that is DS of Old Middletown.

Planting trees in floodplain if not done as part of a stream restoration project.
